# SOLAR - CORRECTING BUILD QUALITY

## IDENTIFYING POOR DESIGN AND BUILD QUALITY

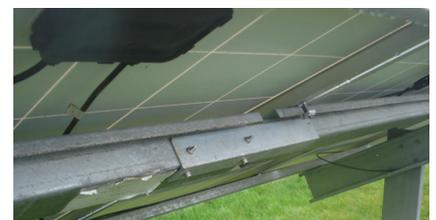
Thermal expansion gaps inserted

The support structure height was adjusted to align and level it. The vertical supports had been inserted into the ground at varying heights creating a waveform on the panels. Instead of a correctly specified panel support structure, recycled rail sleepers had been used. The support rails had no thermal expansion gaps which caused the rails to flex and expand during hotter weather, which could lead to panel cracking. The structure was also showing signs of corrosion. RES introduced thermal expansion gaps in the support rails, supported by splice kits to accommodate material expansion. All untreated and corroded metal received anti corrosion treatment. RES replaced corroded and uncompliant fixing clamps on the panels by an approved clamping system. All faulty cable connectors which were susceptible to water ingress and failing, were replaced using good quality connectors.

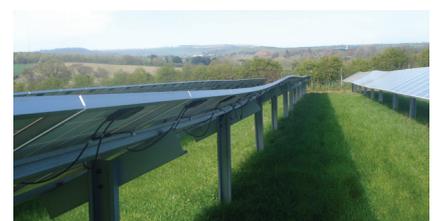
The solar farm had uneven supports

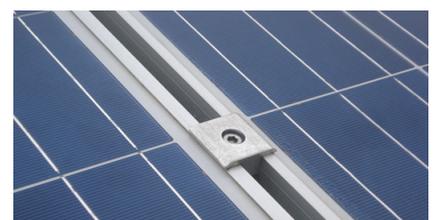
Proprietary clamping system

- » Strengthening and rectification of the non-standard and corroded support structure
- » Replace non-compliant solar panel clamping system which was causing varied panel orientations and cracking
- » Prevention of water ingress to cables connectors and re-routing cabling to reduce distress
- » Essential spare parts replenished. This included string inverters, solar panels, cable connectors, isolators and cables
